**STRENGTHENING OF INFILL MASONRY WALLS USING  
BONDO GRIDS WITH POLYUREA**

**SUMMARY**

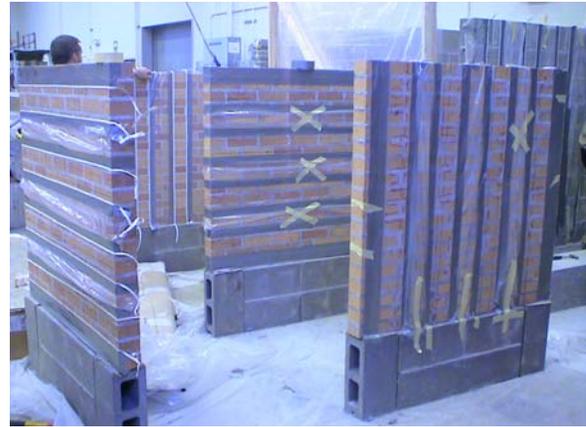
**Figure 2. Before spraying**

Before application of the polyurea, epoxy paste was used to level the rough surface of the walls, where the polyurea was to be sprayed. Next, the surrounding areas of the walls were covered by thick plastic sheets. In all strengthened walls, the polyurea was first sprayed to the assigned places, followed by attaching one ply glass grid to the polyurea immediately. Next additional polyurea was sprayed to the grid until it was completely covered. The surrounding areas of the walls were covered by thick plastic

sheets before spraying, as shown in Figure 2 and 3. This process was identical for the concrete masonry and the clay brick walls.

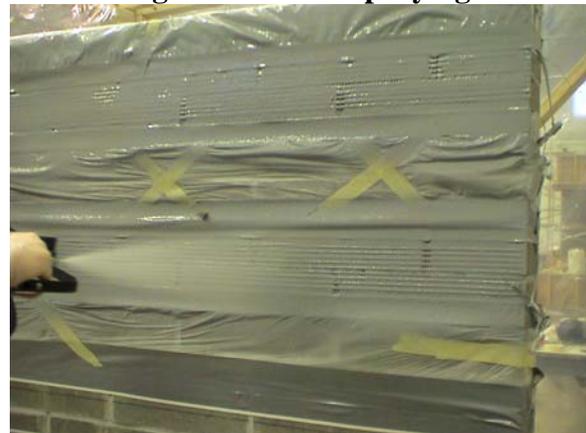
**Figure 3. During spraying**
